ASBESTOS SURVEY

Common Areas of Morshead Mansions

Job Survey No: SWT 236
Job Survey Date: 17.03.2010

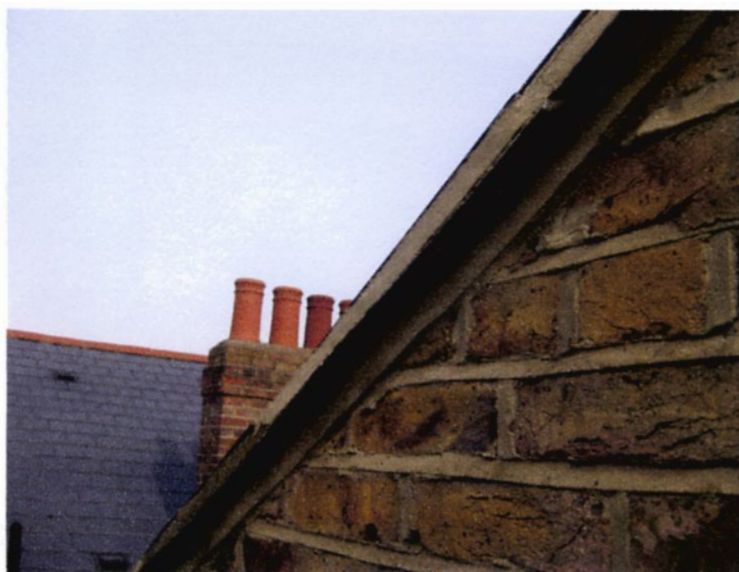
Job Sample No	S 1
UKAS Laboratory	Tersus
Bulk Certificate No	S/SYK 1/129/001
Surveyor Name	PJ Taylor
Survey Type	Type 2

Location	Roof
Floor	Roof
Area	Tile support
Component	cement
Amount	N/A
Asbestos	No Asbestos

ACTION REQUIRED No action required

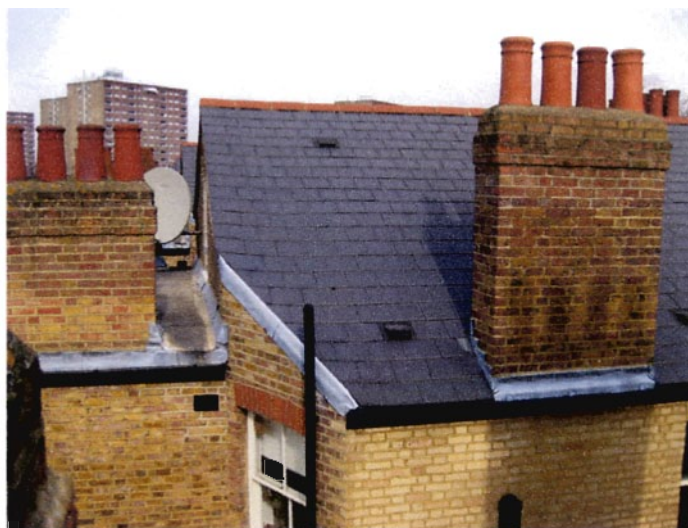
Job Sample No	S 2
UKAS Laboratory	Tersus
Bulk Certificate No	S/SYK1/129/002
Surveyor Name	PJ Taylor
Survey Type	Type 2

Location	Roof
Floor	Roof
Area	Slates
Component	Slates
Amount	N/A
Asbestos	No Asbestos

ACTION REQUIRED No action required
